NACRA Sailing

Dear Nacra 15 and Nacra F16 customer,

We have received reports from Nacra owners about an incorrect fit between the mast base and mast profile.

Productive update Nacra 15 & Nacra F16 mast base to mast connection

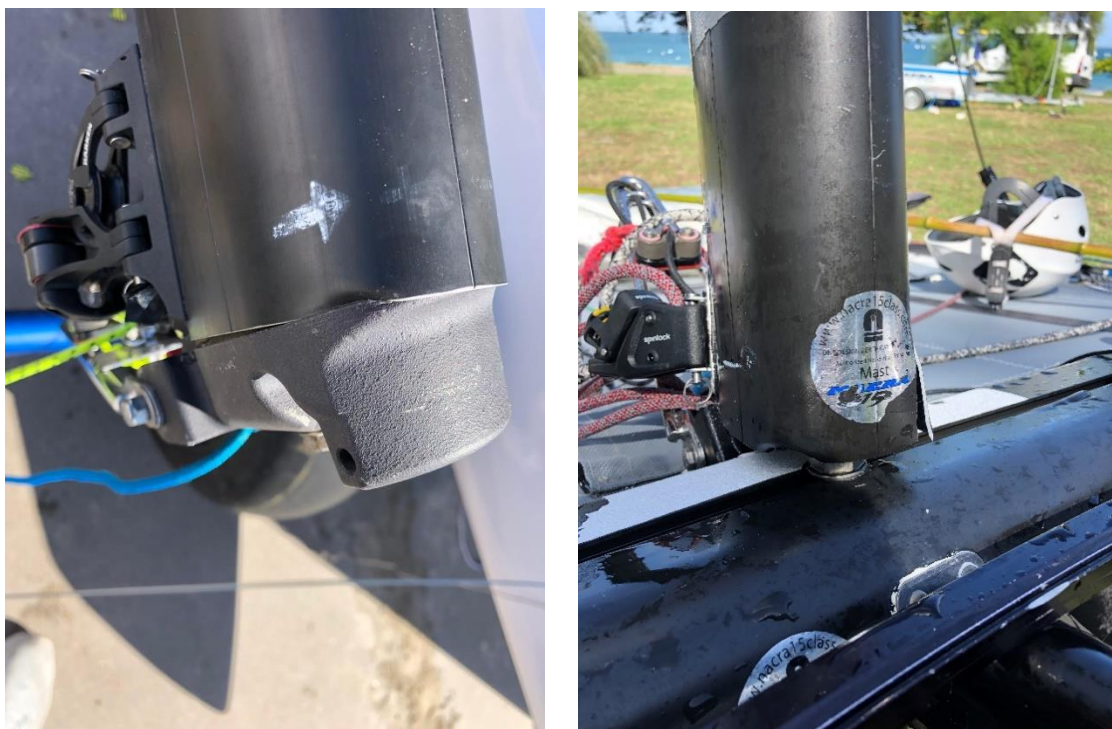
- Too much play between mast foot and mast profile.
- In some cases the mast base was able to penetrate into the mast profile.

Pictures below are from a mast that had too much play and was damaged.

Please disassemble your mast base from your mast

- The mast base can be disassembled by undoing the diamond tension bolt, after the mast is taken down from the boat.
- Check if the standard installed strips are still properly glued inside the mast (see picture below)
- Instal a new 3mm X 30mm X 18mm strip (see instructions below)

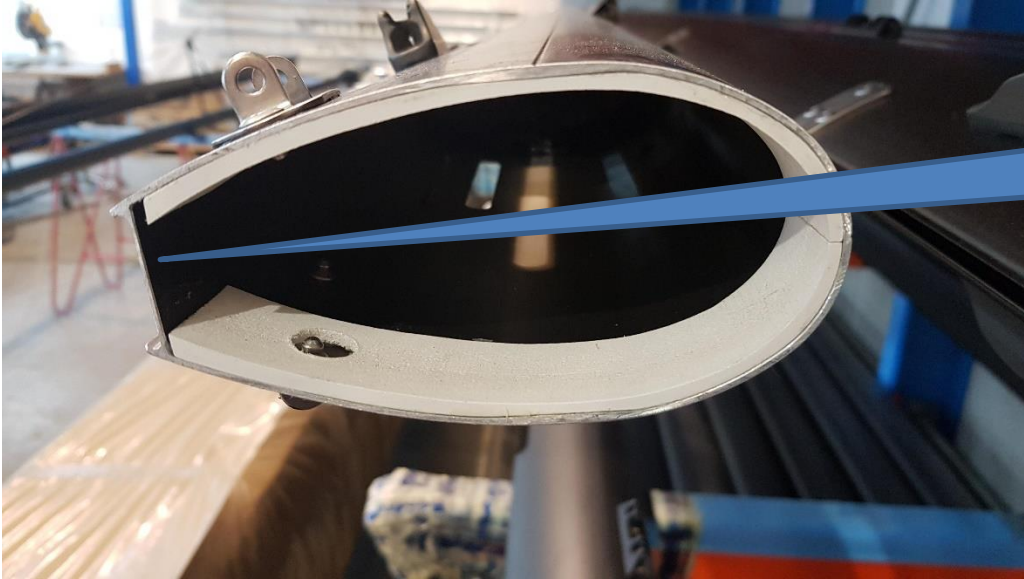
Mast as original
supplied

The above picture shows the original strips glued inside the mast without the new mandatory strip. Please check if the original strips are still properly glued.
